Successful repair and modernisation of a high-temperature pulp drying plant

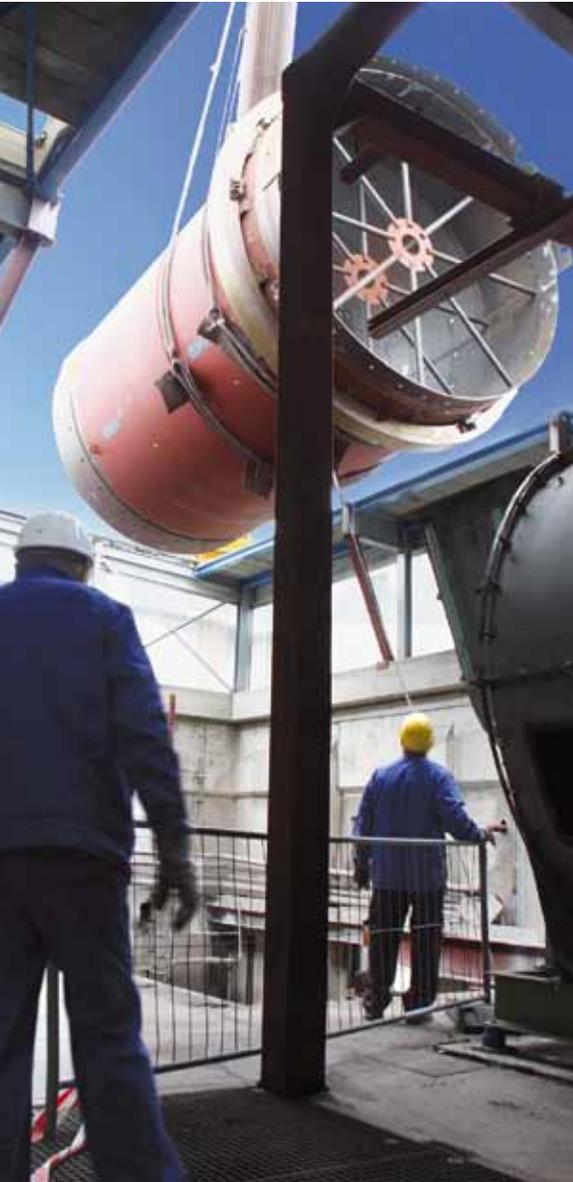
Lifting the drum segments into place

The order included the disassembly of all plant components to be replaced, and the complete assembly of the BMA equipment supplied. A particular highlight was the transport and handling of the drum components with individual weights of up to 54 t and dimensions of about 5.3 m, which were lifted into place over the factory roof.
